Manhole Inspection Summary

Manhole # S47I2_010MH

Insp Date: **1/14/08 12:47 PM**

Location Address: **4515 Pennington Ave**

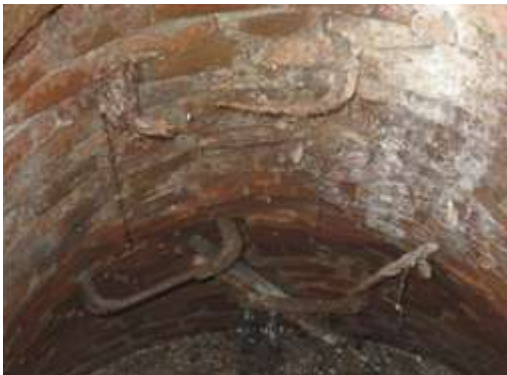
Steps Count: **4** Missing: **2** ☒ **Corroded**

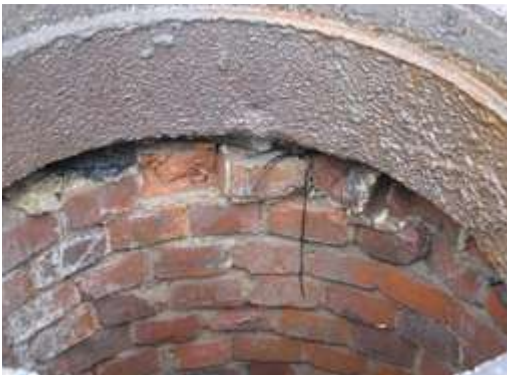
Defect 1

Condition: ☐ Sound ☐ Cracked ☐ Root Intrusion ☒ **Loose Brick** ☐ Deteriorated

Infiltration: ☐ None ☐ Joint ☐ Cracks ☐ Mortar ☐ Roots ☒ **Wall**

Chimney

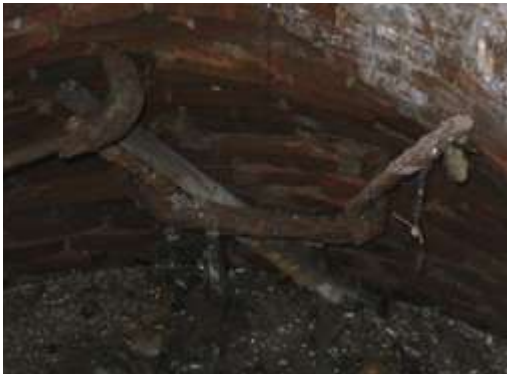
Defect 2

Steps

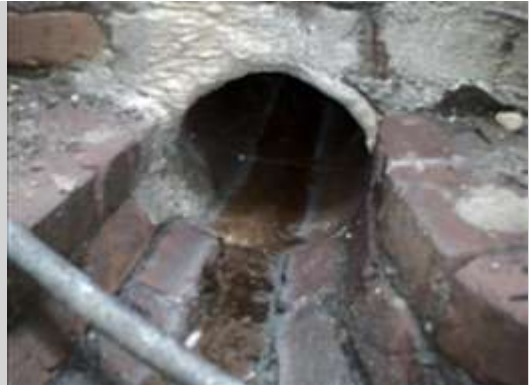
12 O'Clock Outflow

8 in. Circular Gravity Sewer
Pipe Out @ 12 O'Clock

Pipe Height: **9.6** (in.) Rod and Bar (Angled)
Pipe Material: **Clay** ☐ Pipe Lined
Invert Depth: **8.23** (ft.) Flow Characteristics: **Fast**
Deposits: ☒ None ☐ Mud ☐ Sludge ☐ Debris ☐ Grease
Silt Depth: (in.) Deposits Extent:
Infiltration: **None** Pipe Seal Cond: **Sound**

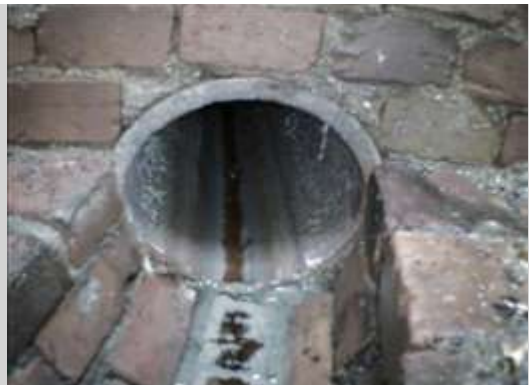
3 O'Clock Inflow

8 in. Circular Gravity Sewer
Pipe In @ 3 O'Clock

Pipe Height: **9.6** (in.) Rod and Bar (Angled)
Pipe Material: **Clay** ☐ Pipe Lined
Invert Depth: **7.87** (ft.) Flow Characteristics: **Fast**
Deposits: ☒ None ☐ Mud ☐ Sludge ☐ Debris ☐ Grease
Silt Depth: (in.) Deposits Extent:
Infiltration: **None** Pipe Seal Cond: **Sound**

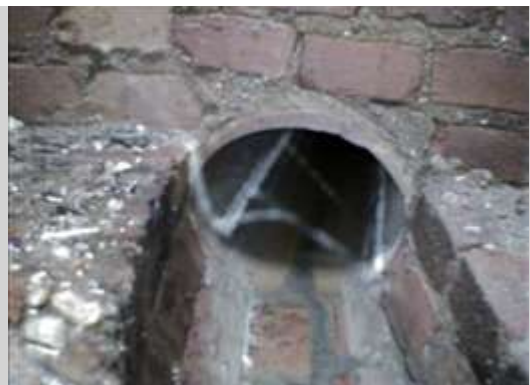
9 O'Clock Inflow

Pipe In @ 9 O'Clock

Infiltration: **None** Pipe Seal Cond: **Sound**
